## Update “With-Site-Visit” Reserve Study

### San Ignacio Vistas HOA Green Valley, Arizona

Report #: 15861-1  
For Period Beginning: January 1, 2013  
Expires: December 31, 2013

Date Prepared: September 24, 2012

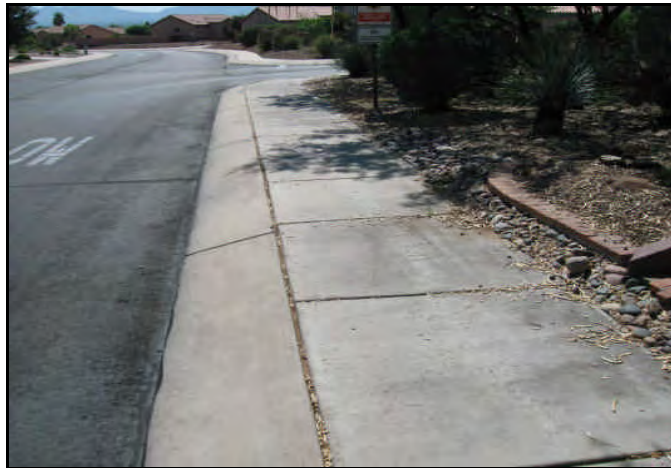
**Comp #:** 103 Concrete - Repair

Evaluation: There is no expectancy to completely replace the concrete. This component provides an allowance for periodic repairs and/or partial replacements. There is a low spot of curbing on View Ridge Drive that needs to be corrected to eliminate the pooling water. This will be addressed as part of the erosion projects.

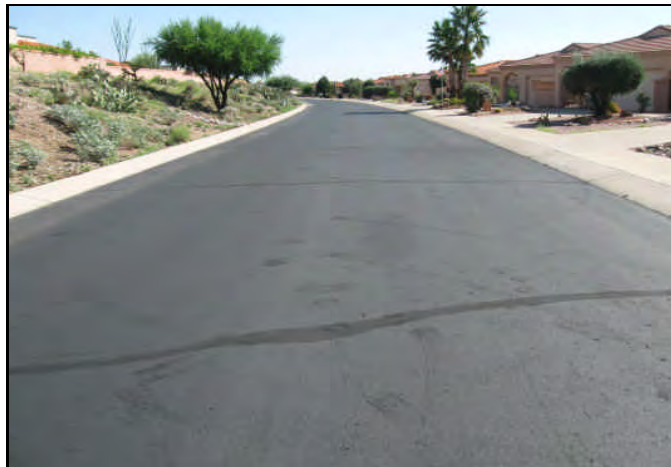
Evaluation: Streets are original from 1997. Moderate cracking noted throughout community. Some of the cracks are large. No signs of failure or alligating though. Pavement still appears to be in good to fair condition overall. Life span is based on planned application of a SAM coat and periodic sealing.

Best Case: \$697,000.00  
\$1.67/Sq Ft; Estimate to pulverize & repave

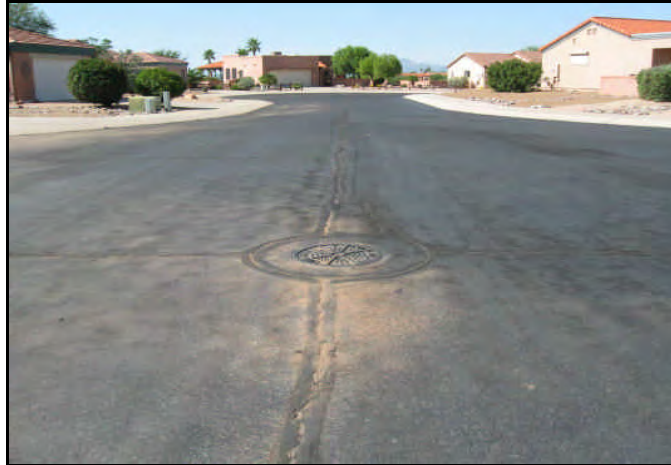
**Comp #:** 202 Streets - Major Repair

Evaluation: HOA had some major repair work done in the past and reportedly has another area that will also need work in the near future. This component provides a one time repair for that area as requested by the HOA. Cost allocation is also based on the HOA's budget. Expect to perform this repair prior to the SAM coat application.

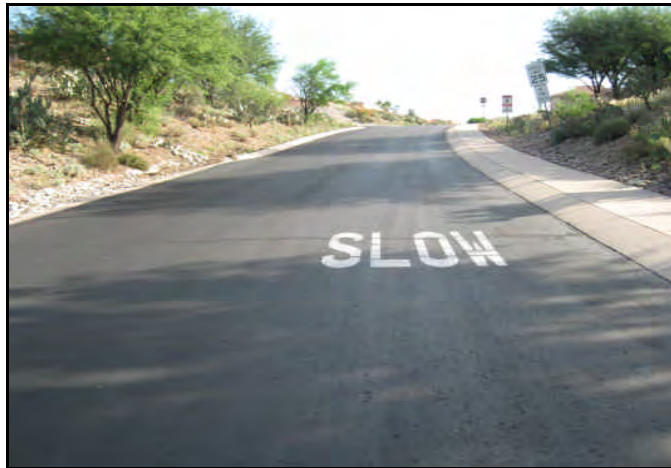
**Comp #:** 206 Streets - Seal/Repair

Evaluation: Streets were repaired and sealed during April 2012 for \$28,599. Seal looks new and is in good condition. Dark and uniform application. Remaining life is higher than the scheduled useful life, because it reflects sealing 4-years after the SAM coat is applied.

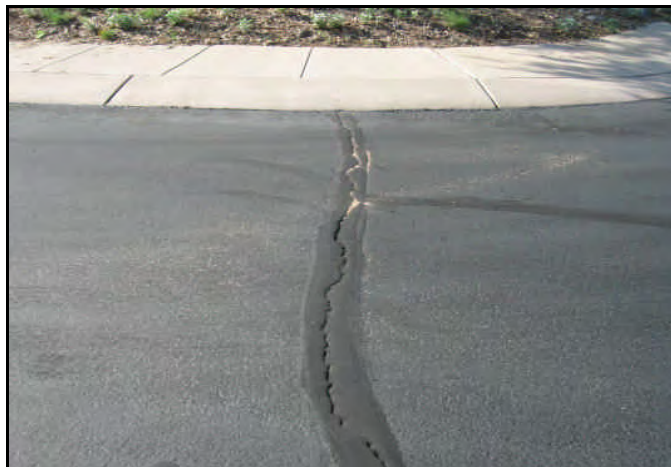
**Comp #:** 207 Streets - Crack Seal

Evaluation: Crack sealing was completed during February 2012 for \$7,858. Cracks look well sealed and are in good condition. Once the SAM coat is applied, crack seal should not be needed as frequently, and the cost will likely be less.

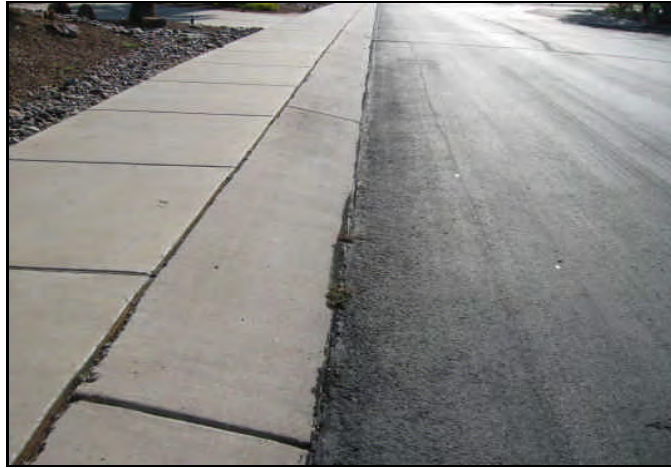
Evaluation: Sunland Asphalt recommended HOA plan to periodically seal the cracks along the curb line throughout the community. This helps to prevent water intrusion below the asphalt base. HOA spent \$15,879 in 2008 and \$19,090 in 2009 for both crack and curb sealing. The amount for just curb sealing is unknown, but HOA had a proposal for \$19,601 in 2007.

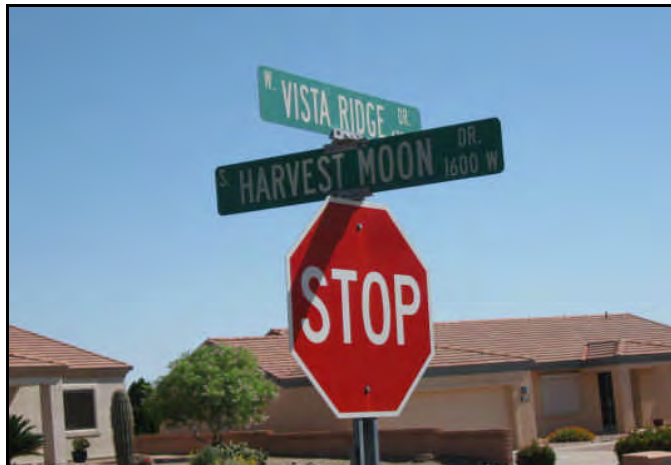
**Comp #:** 250 Street Signs - Repair/Refurbish

Evaluation: Street signs appear to be typical, city style signs. Because streets are private, HOA is responsible to repair or replace them. HOA spent ~\$1,700 on signs from 2004 to 2006. This component funds for periodic sign repairs and/or refurbishing.

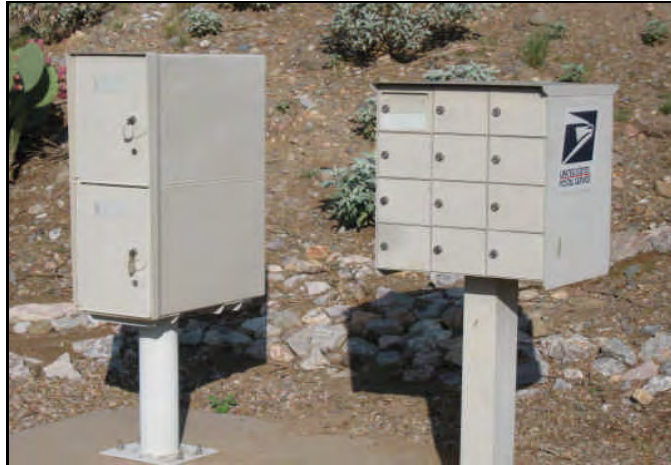
**Comp #: 403 Mailboxes - Replace**

Evaluation: These mailboxes are aluminum, mounted to a pedestal. The Post Office is responsible to replace them in the future, not the association. No Reserve funding required.

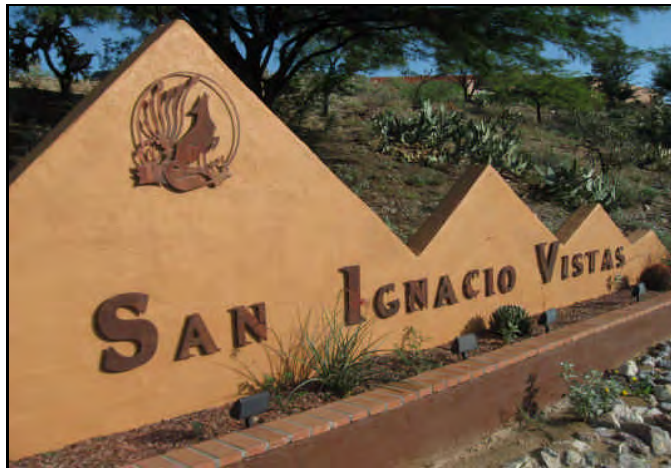
Evaluation: Original from 1997. These are solid metal cutout letters mounted to stucco walls. Long life expectancy under normal circumstances. This component funds for eventual replacement of the letters to update or modernize the appearance.

\$3,300/Monument; Estimate to replace the letters

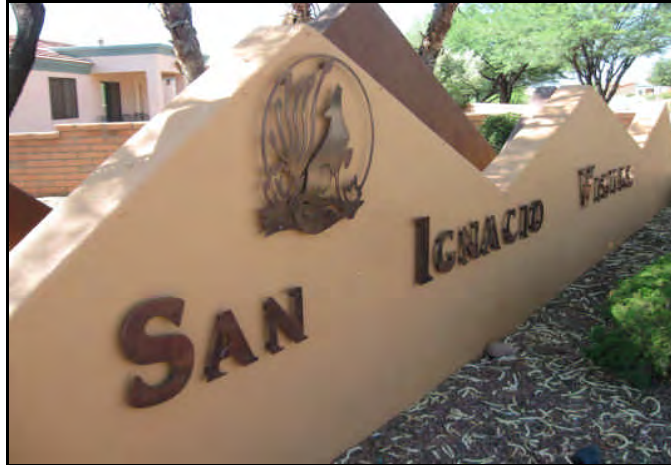
Evaluation: The original monument lettering from 1997 was powder coated in 2005 for \$815. Finish is still in good condition. This component funds to powder coat the letters periodically between scheduled replacement to maintain the appearance.

\$450/Monument; Estimate to powder coat the letters

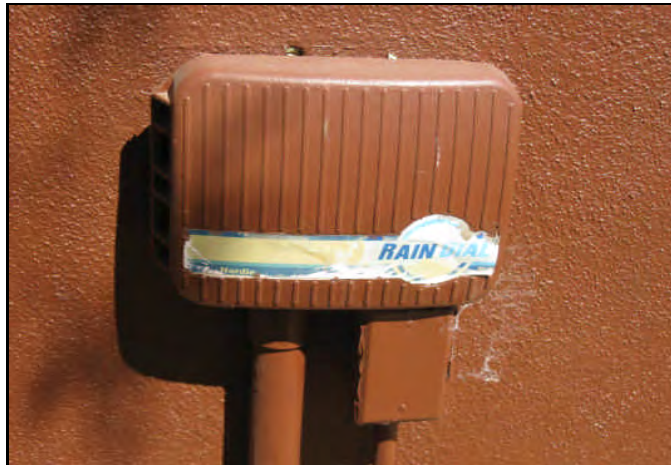
**Comp #: 1003 Irrigation Controller - Replace**

Evaluation: Actual age of the controller is unknown. Appears to be functional. Replacement cost is too small for Reserve designation, so no funding has been allocated. Treat replacement as a maintenance expense.

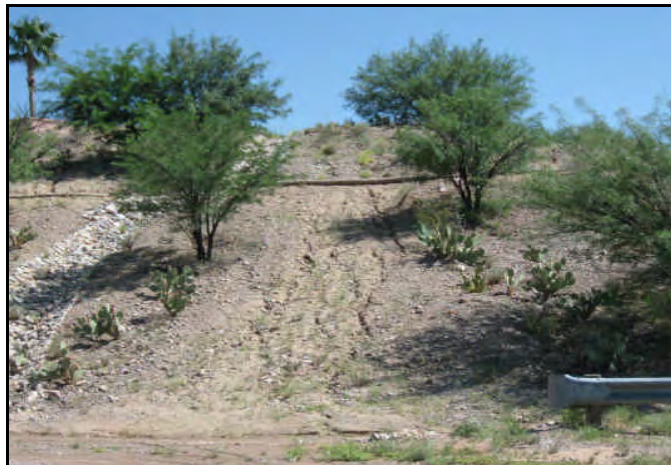
Evaluation: HOA recently hired Westland Resources to inspect the community for erosion issues and to create a scope of work for repairs. Westland identified 6 major areas of the community that need attention with an estimated repair cost of \$66,575. We anticipate this work will be spread over 3-years and have included funding as a one-time expense.

Allowance for 1/3 of the erosion mitigation repairs

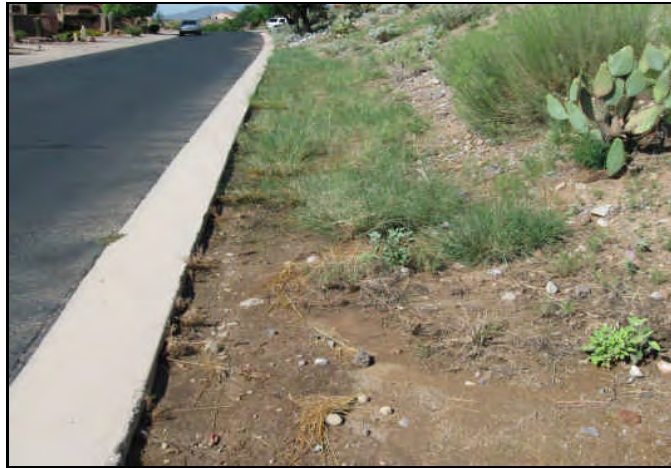
Evaluation: This component reflects the 2nd phase of erosion repairs, currently scheduled for 2014.

Allowance for 1/3 of the erosion mitigation repairs

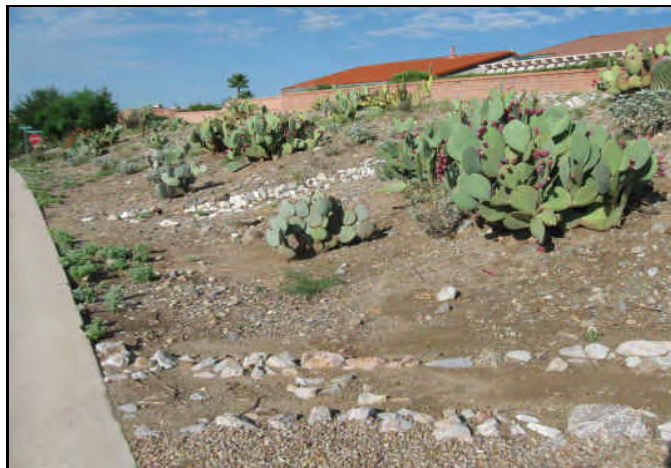
Evaluation: This component reflects the 3rd phase of erosion repairs, currently scheduled for 2015.

Allowance for 1/3 of the erosion mitigation repairs

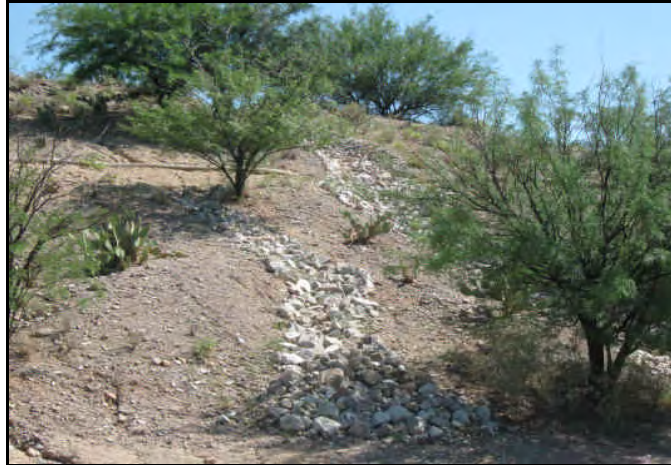
Evaluation: Prior to the anticipated upcoming mitigation expenses totaling over \$66,000, HOA spent \$55,667 on various erosion projects from 2004 to 2012. Majority of this expense was during 2004. Due to the hillside location of this community, HOA should always anticipate some repairs to both prevent and repair erosion problems.

Allowance for erosion mitigation repairs

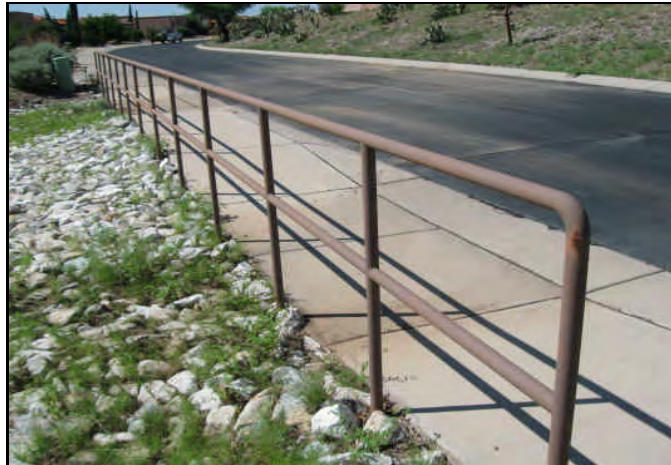
Evaluation: The rails are faded and have some surface rust. Chipped paint was also noted. Repainting should be planned periodically to protect the metal and to restore the appearance. The cost to paint these rails is too small for Reserve designation. Treat painting as a maintenance expense or include with other painting projects.

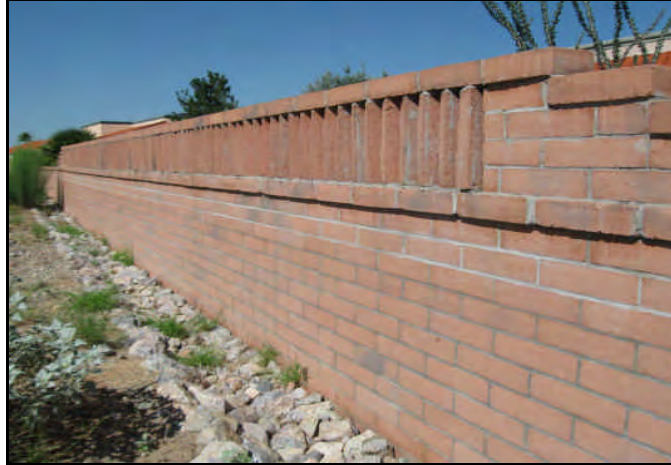
**Comp #: 1104 Block Walls - Paint/Repair**

Evaluation: Rear yard walls are unpainted block, so painting is not necessary. Repair work is likely at some point in the future; however, owners' are responsible for their yard walls, not the HOA. No Reserve funding is required.

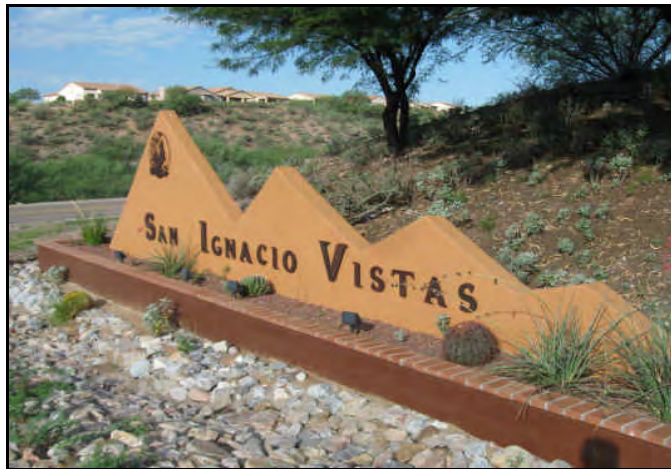
Evaluation: Stucco monument walls were repainted during November 2011 for \$900. Surfaces look new and are in good condition. Repaint periodically to maintain and restore the appearance.

\$0.56/Sq Ft; Estimate to repaint

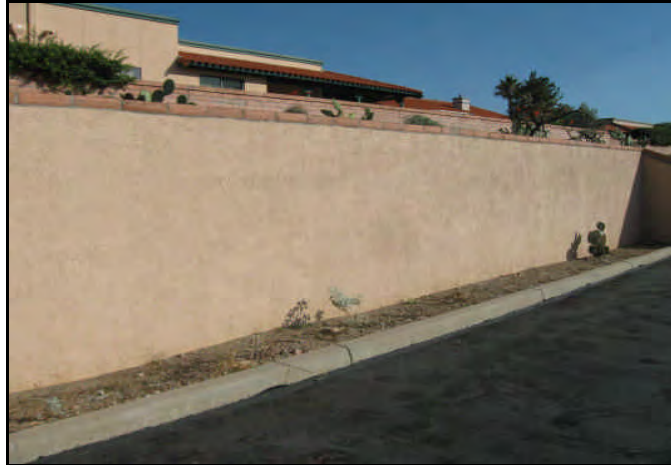
Evaluation: The stucco coated retaining walls at parking areas were last repaired and painted during June 2009 for \$1,138. Surfaces are still in good to fair condition. No significant staining or cracks noted. Repaint periodically to maintain and restore the appearance.

Best Case: \$1,120.00  
\$0.40/Sq Ft; Estimate to repaint
